**Utica Marcellus  
Texas Pipeline LLC**  
a Kinder Morgan company

**Tennessee Gas Pipeline  
Company, L.L.C.**  
a Kinder Morgan company

Re: Nationwide Permit 12 Pre-Construction Notification  
Tennessee Gas Pipeline Company, L.L.C. – Abandonment and Capacity Restoration Project  
Utica Marcellus Texas Pipeline LLC – Utica Marcellus Texas Pipeline Project  
(State of Kentucky)

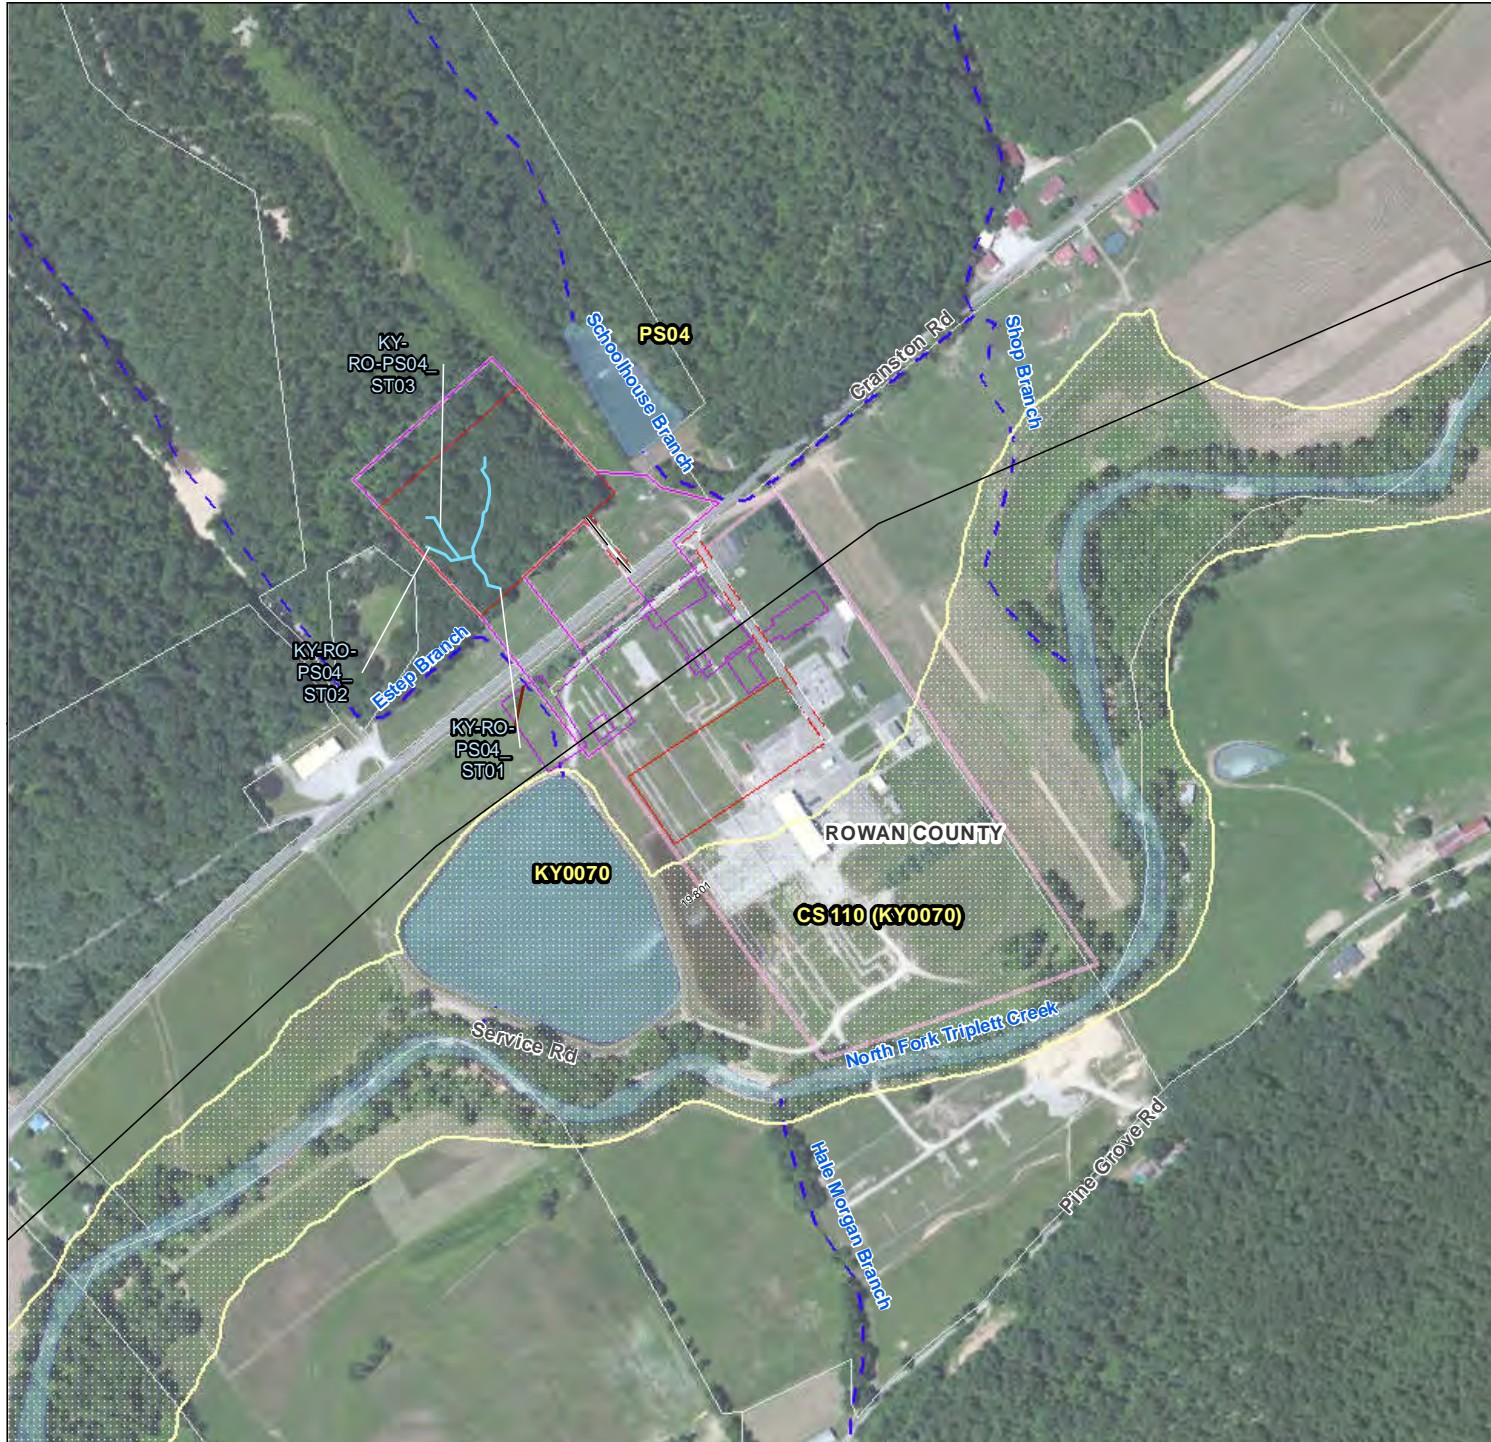
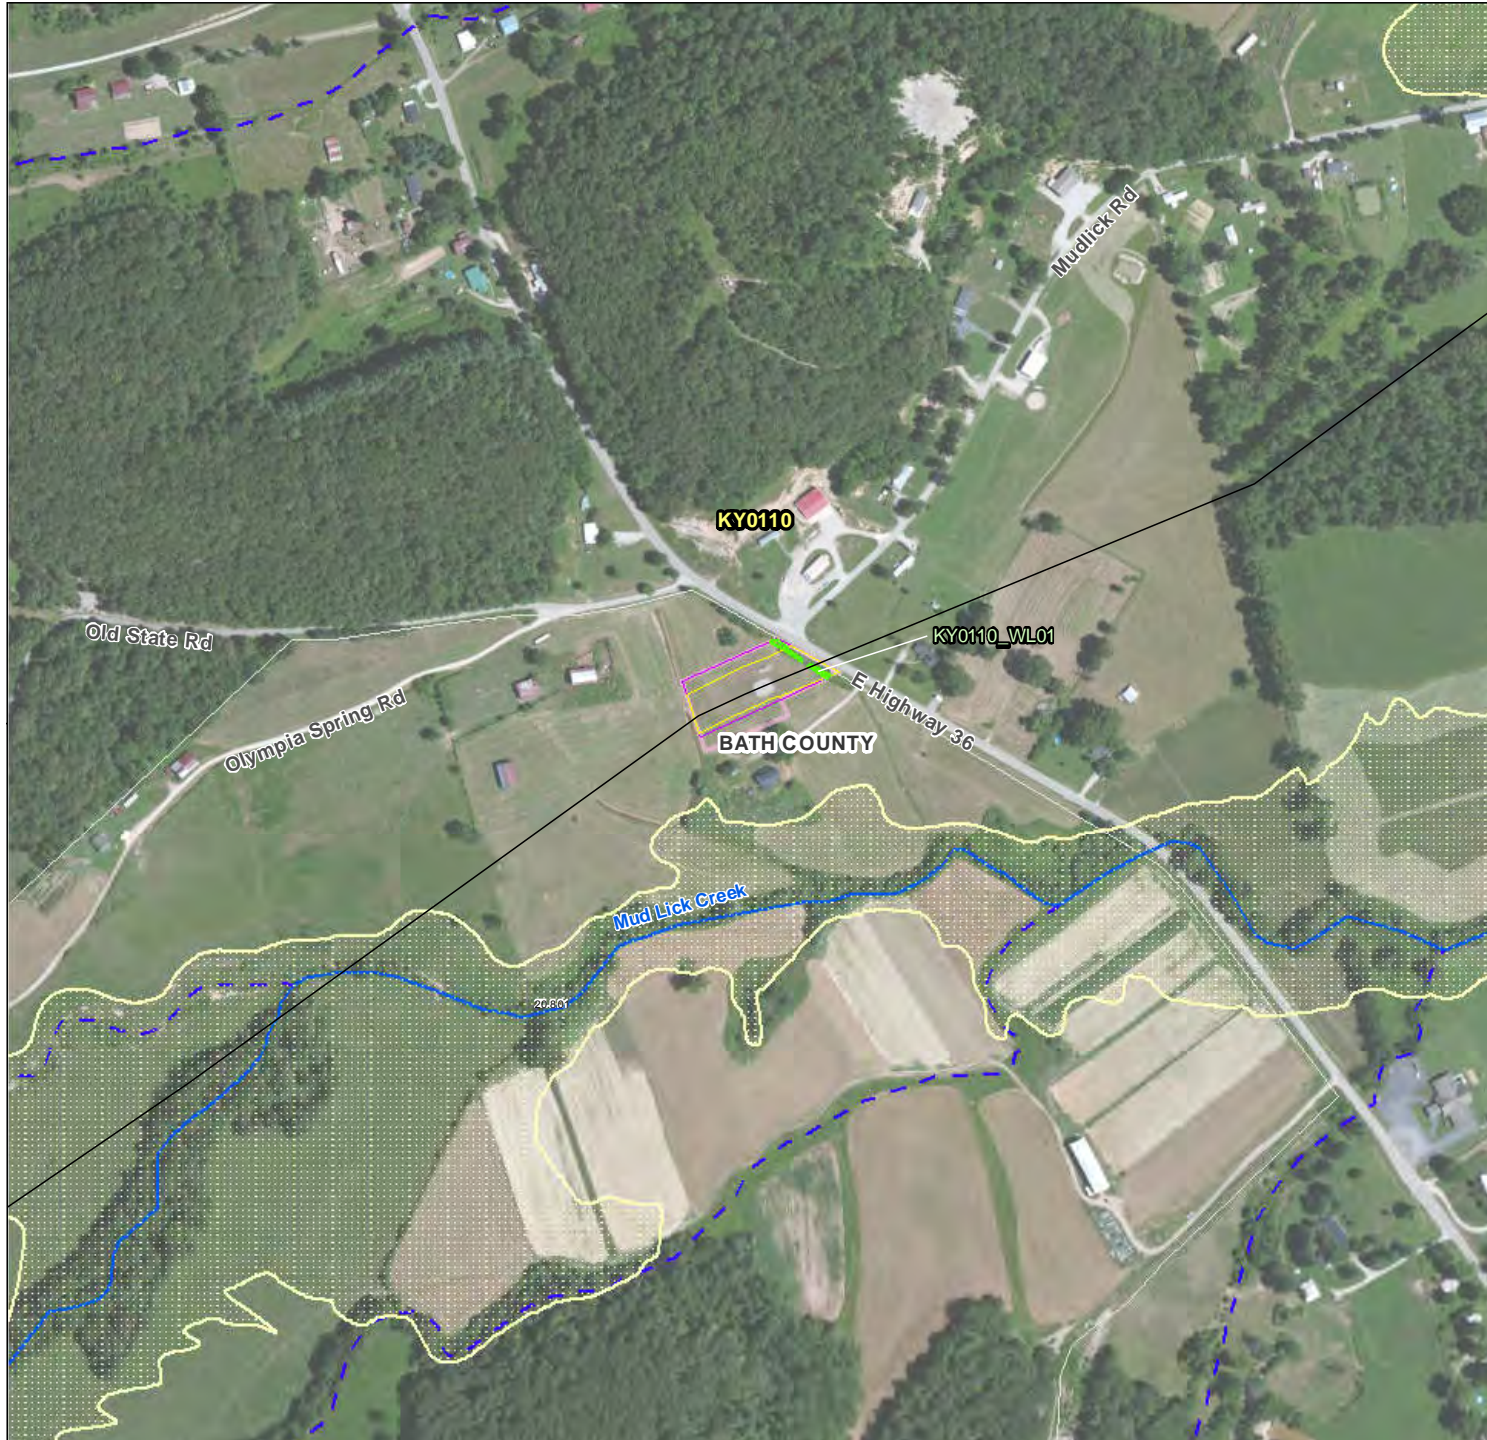
Figure No.  
**3**  
Site

Survey permission from landowners was unavailable along portions of the ACRP and UMTF Project route during field surveys in 2013 and 2014. These areas are located outside of the tan boundary of the survey corridor noted on Figure 3 and are anticipated to be surveyed in the Spring of 2015. The results of these surveys will be provided to the USACE as an addendum to the PCN. To approximate additional potential impacts to WOUS prior to the completion of field surveys, National Wetland Inventory (“NWI”) and the National Hydrography Dataset (“NHD”) were reviewed to preliminarily identify potential WOUS present within the non-surveyed parcels. Table 3 provides a summary of these anticipated impacts of WOUS in non-surveyed areas based upon a review of the NWI and NHD data. These NWI and NHD features are not included in the Waters Upload and Impacts Tables provided in Attachment 5 as they are pending field verification. Permanent loss and temporary impact were not calculated for NHD-designated streams in Table 3 as the crossing width of these streams are unknown.

Attachment 3 contains maps indicating the location of the Projects in more detail. Maps included in Attachment 3 also include Flood Insurance Rate Map ("FIRM") Flood Hazard Areas, where available, for locations where the Projects intersect delineated streams or open water.
